TECHNICAL REPORT

### Off-Frequency Tuning Error Artifact in Steady-State Free Precession Cine Imaging Due to Adjacent Air-Filled Bowel

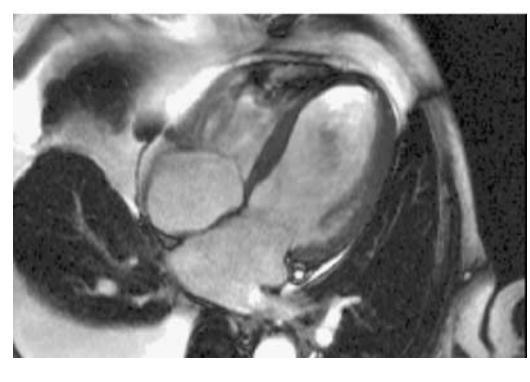
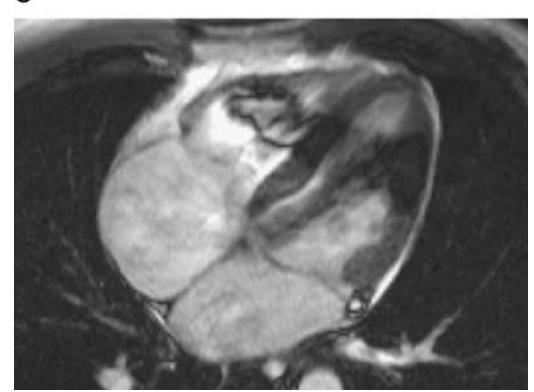
*Figure 1.* Severe off-frequency tuning error artifact (OFF-TEA) in midsystolic frames on horizontal long-axis (four-chamber view) steady-state free precession (SSFP) cine images for cases 1-3 (A–C).

Characteristics of the three subjects are presented in Table 1. Cardiac diagnoses were diverse. Each artifact was readily apparent and predominantly located in the apical portion of the ventricular chambers of SSFP gradient echo sequences (true FISP). Figure 1 shows midsystolic frames for the three cases (Fig. 1A-C). Seen are moderate to large, black, off-resonance artifacts in blood and myocardium spanning approximately 40%-80% of the right ventricle (RV) and 5%-60% of the left ventricle (LV). These are in distinct contrast to the surrounding white blood. These undulating, swirling artifacts in cine displays are reminiscent of dense, black smoke and create variable degrees of clinical obstruction. They were most prominent in the systolic phases (Fig. 1), but they could be readily demonstrated throughout the cardiac cycle (Figs. 2 and 3). Although these artifacts are seen in different imaging planes, they vary in appearance depending on the direction of flow relative to the imaging plane.

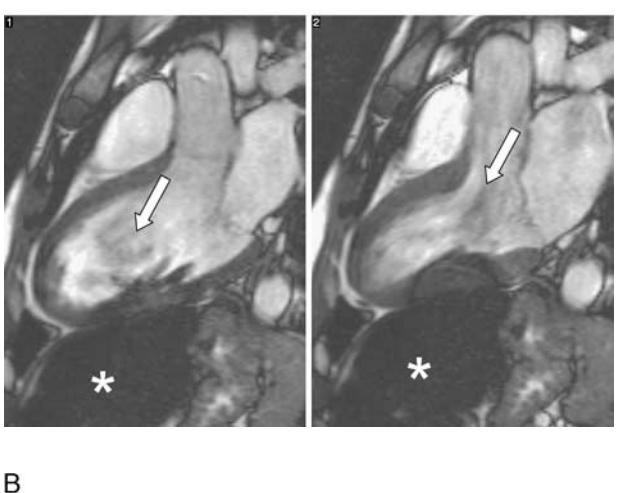
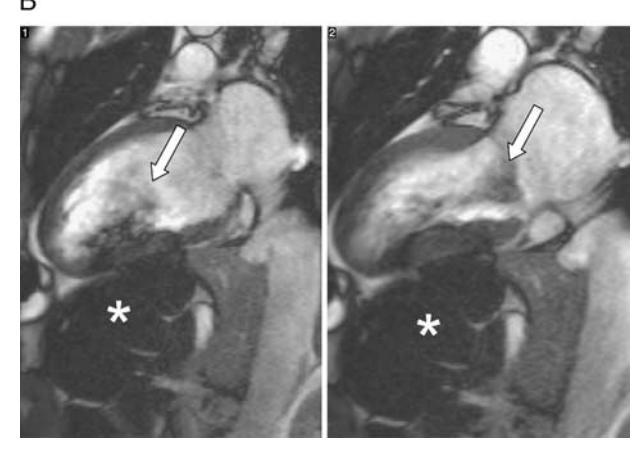
*Figure 2.* SSFP sequence, oriented in the apical (A) and vertical (B) long-axis (three-chamber and two-chamber views, respectively) of case 2 highlighting the relationship of the subdiaphragmatic air-filled bowel (\*) and the adjacent OFF-TEA (arrow). Diastole: left. Systole: right.

The two-chamber (vertical long-axis) and threechamber (apical long-axis) views of the left ventricle are extremely valuable in clarifying the relationship of the inferior and inferolateral borders of the myocardium and adjacent bowel (Figs. 2 and 3). These views provided the necessary insight into the marked adjacent bowel gas which was not visible on the most profoundly affected four chamber (horizontal longaxis) views. Other causes for the 'black smoke' initially considered during the routine clinical review of two of these cases included an apical thrombus with surrounding flow disturbance and a neighboring ferromagnetic object not identified in prescanning screening.

In each of the three cases, a large air-filled, subdiaphragmatic loop of colon or stomach was present (Figs. 2 and 3). The diameter of the air sac was 6 cm or more. These were in close proximity (within 2 cm) to the heart. The full extent of air-filled bowel was readily noted on the initial transverse black blood spin echo sequence (Fig. 4).

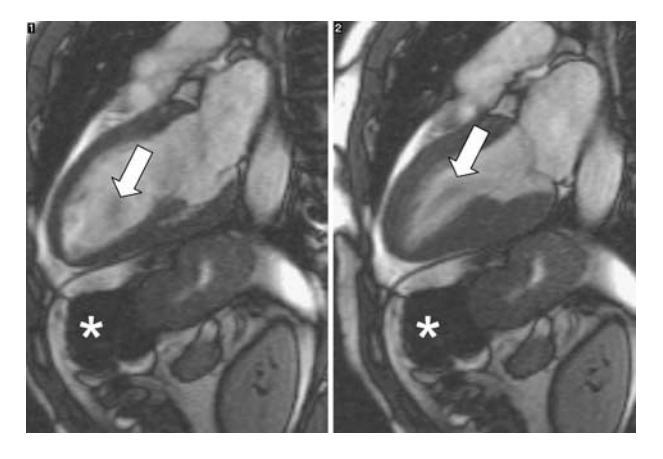
*Figure 5.* SSFP vertical long-axis image in case control 2. A small pocket of air (\*) was noted in the stomach >4 cm below the heart border and created a mild OFF-TEA (arrow).

Five of six matched patient controls had neither OFF-TEA nor air pockets adjacent (within 2-4 cm) to the heart (Table 1). Control subject 2 had a small, faint, midcavity LV artifact that did not affect the clinical interpretation of the examination. This was associated with a 3.7-cm air bubble in the stomach that

was more than 4 cm below the LV apex (Fig. 5). This patient had normal LV systolic function.

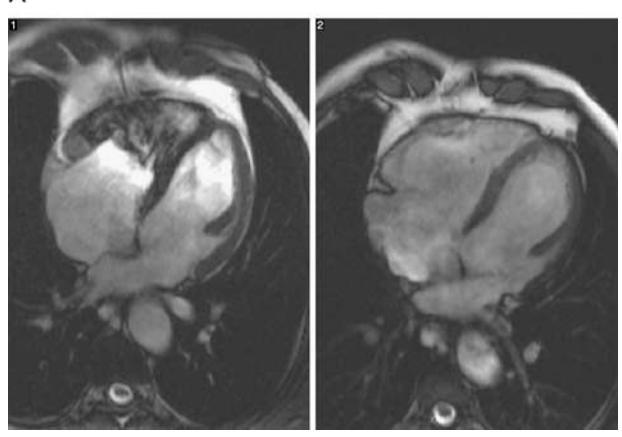
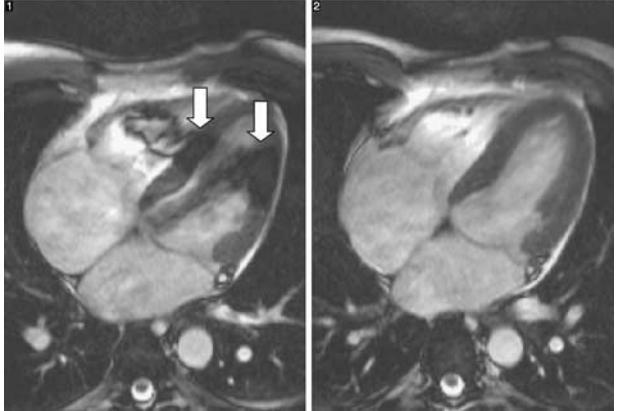
*Figure 6.* Elimination of the OFF-TEA was not achieved by reducing adjustment region for shim and automated RF correction (left) but was achieved by manually correcting the error in automated selection of tuning frequency (right). (A) Case 1. (B) Case 2. Note the involvement of the myocardium as well as the cavity (arrows).

Reducing the size of the region used by the scanner software for calculating the shimming adjustments was not successful in eliminating this cardiac artifact (Figs. 6A and B, left panel). However, adjusting the scanner's RF tuning proved successful (Figs. 6A and B, right panel).

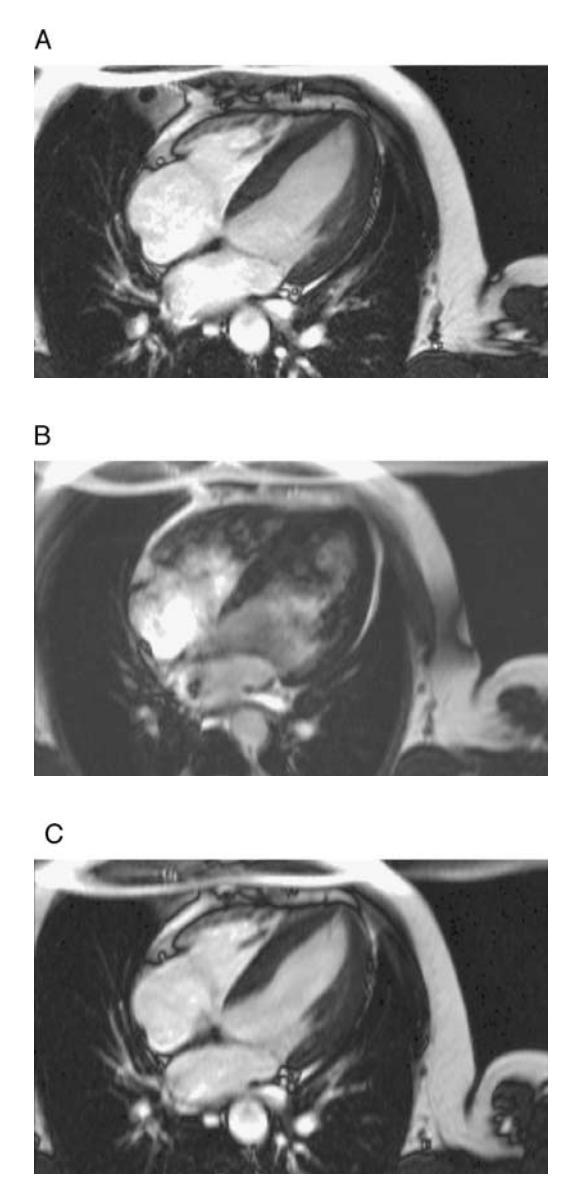
*Figure 7.* Creation of OFF-TEA by imposing a frequencytuning offset in a randomly chosen subject. (A) Baseline. (B) After introducing off-frequency scanner RF tuning error (200 Hz above water resonance). (C) After correcting OFF-TEA (retuned to the water resonance frequency). (Also see Fig. 8.)

A readily apparent OFF-TEA was artificially generated in a normal individual by raising the system's RF arbitrarily by 200 Hz. Setting the RF back to the 'water-peak' baseline value corrected the artifact (Fig. 7A-C).

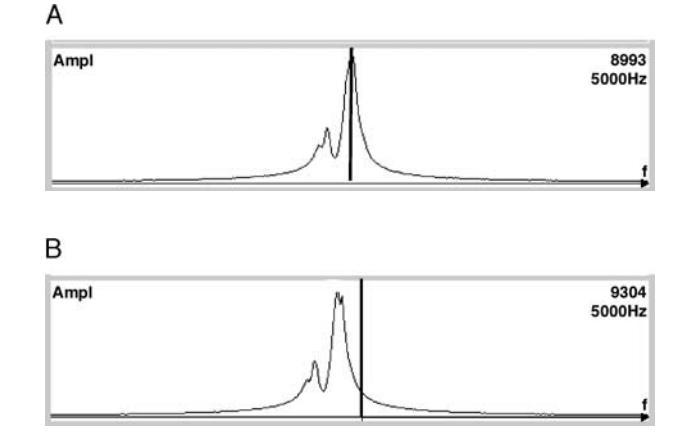
*Figure 8.* Representative display of fat (left peak) and water (right peak) frequency spectrums. The baseline automatic frequency option was 63.661808 MHz (A). The vertical black line, at 63.662009 MHz, shows representative position manually chosen to create the off-frequency tuning error artifact shown in Fig. 7B (B).

spectrum obtained from the scanner's clinical user interface illustrating fat and water resonant frequencies for this subject (Fig. 8). Manually adjusting the resonant frequency to tune into the water peak eliminated the artifact.
